# **FIELD INVESTIGATION OF DERBIGUM SP SINGLE-LAYER ROOFING**

Client's name:  
 Performance Roof Systems SA-NV

| Project.no:<br>O-10114 | Date:<br>1.February 2001 | Rev.date:<br>9.February 2001 | Nber of pages<br>8 | No. attachments<br>0 | Graduation<br>Closed | Authors<br>Trond Bøhlerengen<br>Knut Noreng |

**Assignment Report**

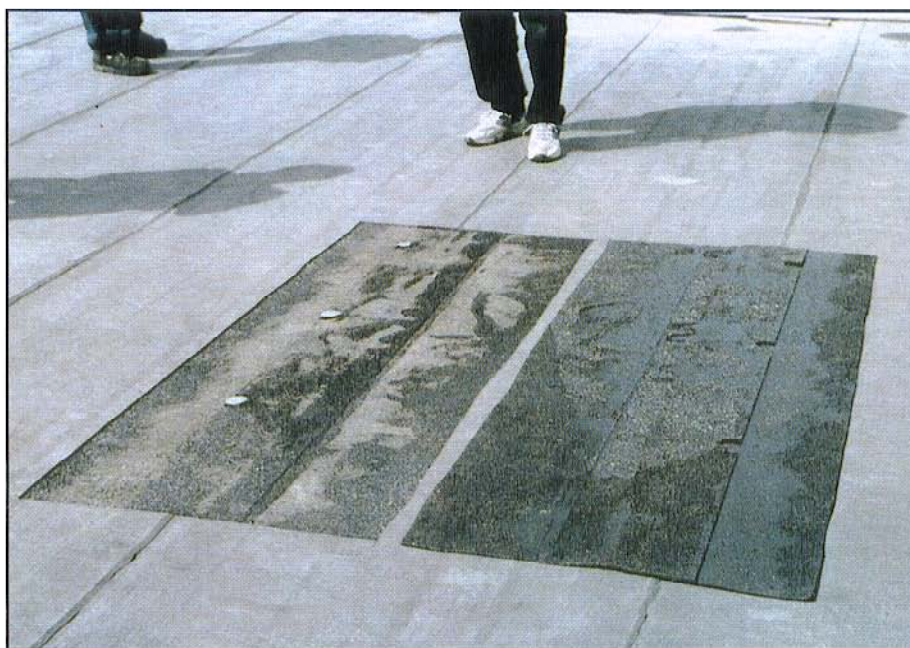
**Photo 1:** Sample taking. The roofing was mechanically fastened to the old roof. Underlayer was old asphalt roofing. The fasteners are placed close to the edge of the roofing (from T9).

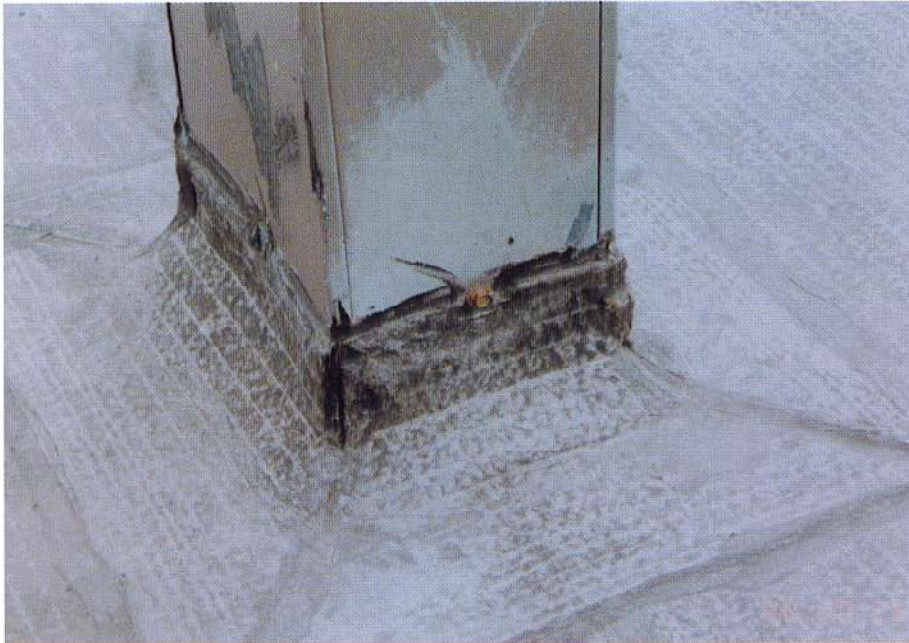
**Photo 16:** The roofing is welded outside the bushing and is in good shape after 10 years (from T2).

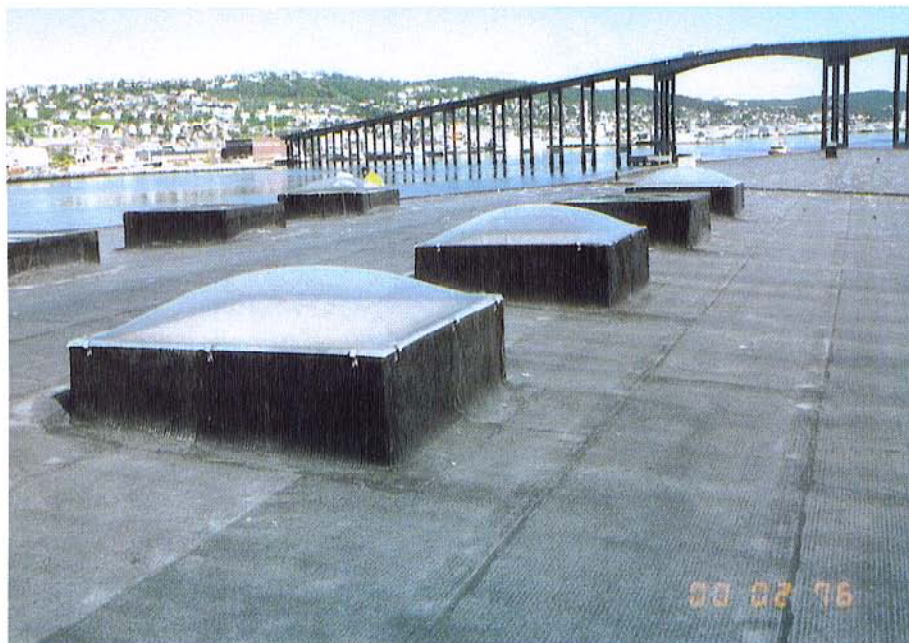
**Photo 20:** A large roof with a lot of sky-lights. Well done workmanship (from T14).

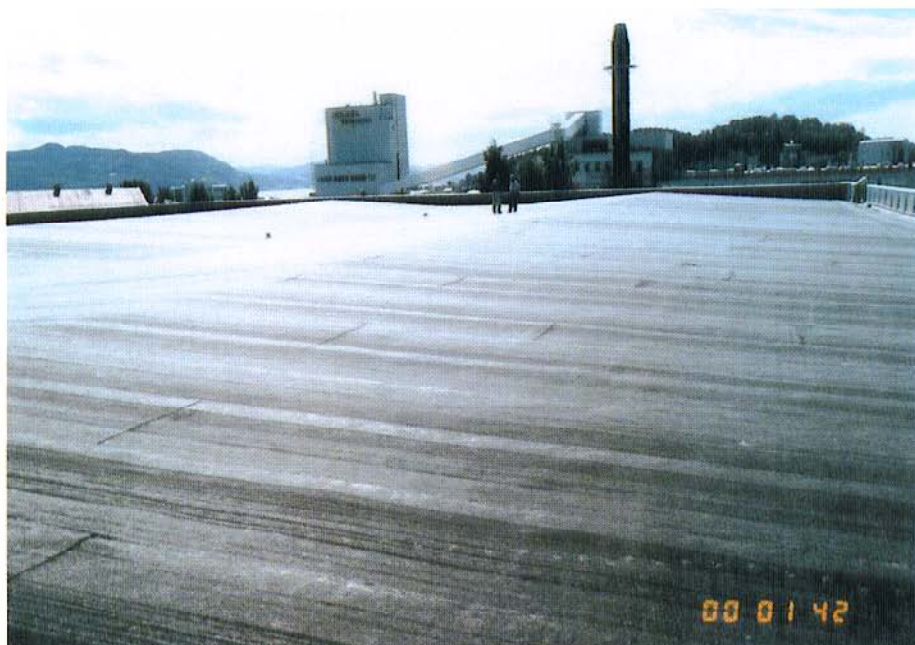
**Photo 30:** Example of excellent roofing (from T10).
